SURVEY FOR ASBESTOS-CONTAINING MATERIALS FOR

Cemetery Bungalow

A3124
Winkleigh
Devon
EX19 8HZ

ASBESTOS SURVEY REPORT

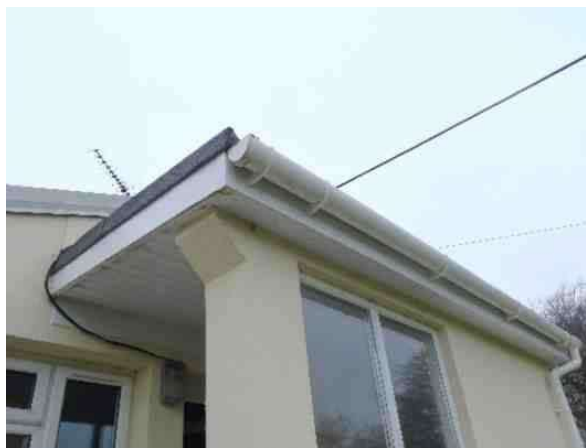
Item Number : 01490-001

Description : Conservatory

Asbestos Type : No Asbestos Detected

New construction

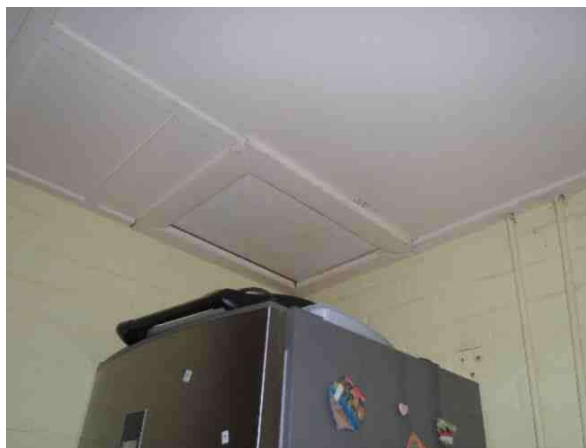
Item Number : 01490-002

Description : Access to loft

Identification : No Access

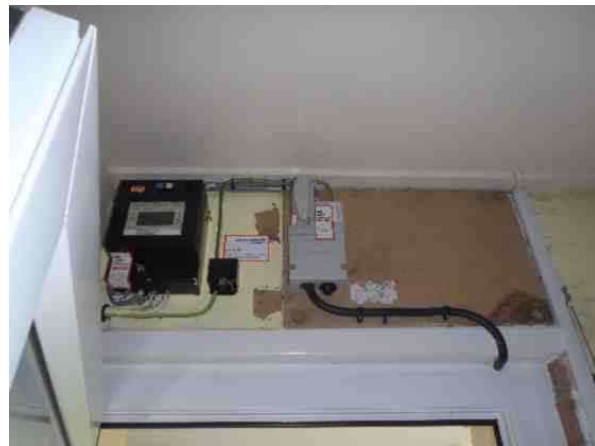
Item Number : 01490-003

Description : Mounting board for electricss

Asbestos Type : No Asbestos Detected

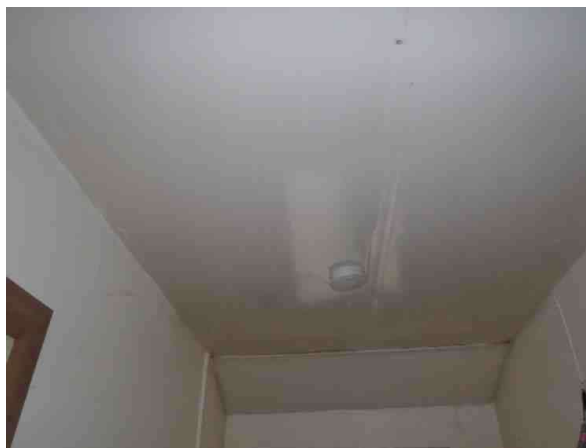
Item Number : 01490-004

Description : Ceiling Board

Asbestos Type : No Asbestos Detected

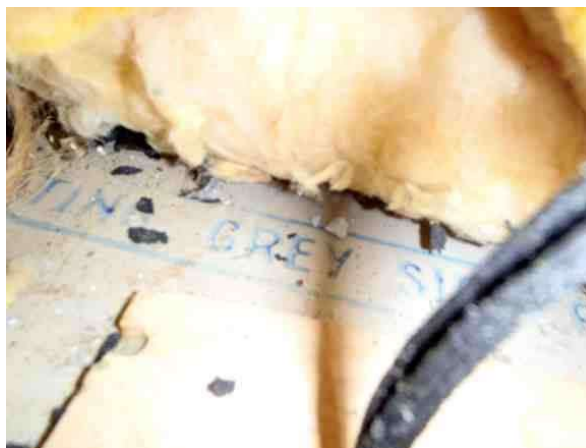
Item Number : 01490-005

Description : Ceiling Board and Debris

Asbestos Type : No Asbestos Detected

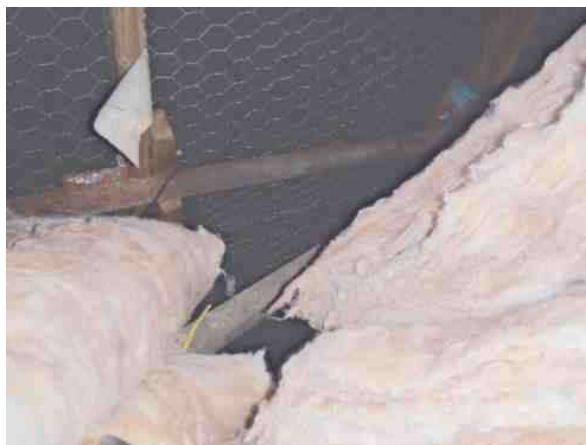
Item Number : 01490-006

Description : General View

Asbestos Type : No Asbestos Detected

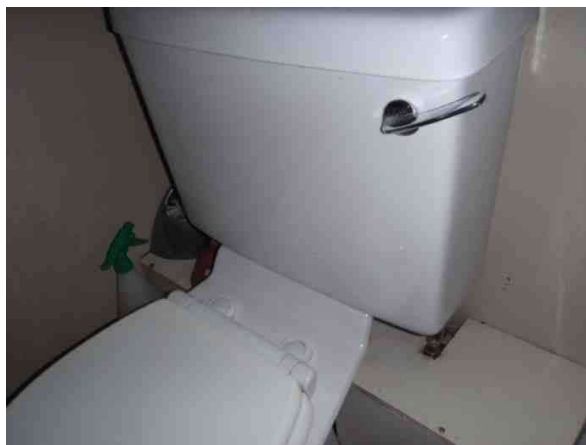
Item Number : 01490-007

Description : Boxing and Coistern

Asbestos Type : No Asbestos Detected

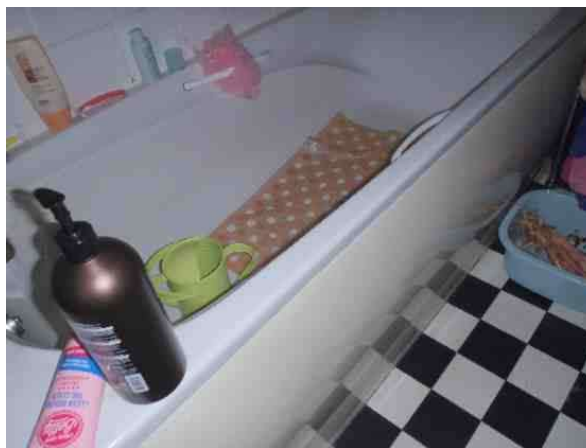
Item Number : 01490-008

Description : Bath Panel and Flooring

Asbestos Type : No Asbestos Detected

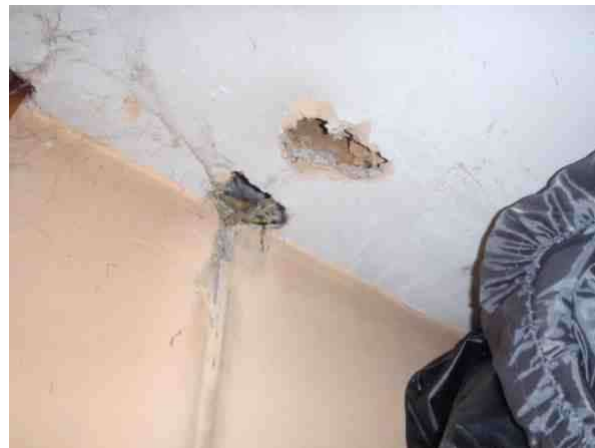
Item Number : 01490-009

Description : Ceiling

Asbestos Type : No Asbestos Detected

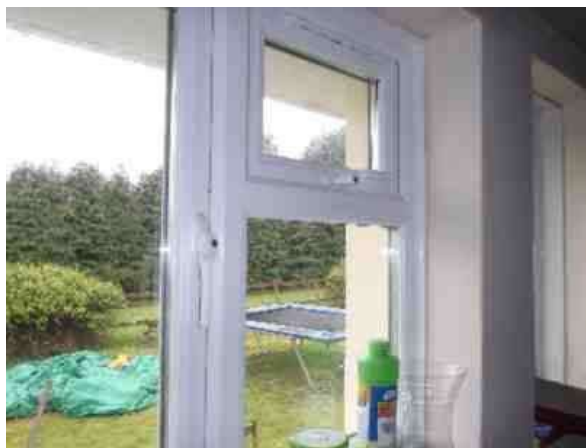
Item Number : 01490-010

Description : Window Fit

Asbestos Type : No Asbestos Detected

Recent Fitment. No asbestos packing

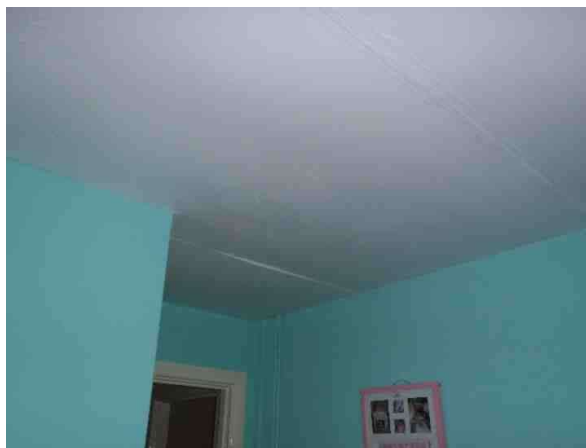
Item Number : 01490-012

Description : Ceilings

Asbestos Type : No Asbestos Detected

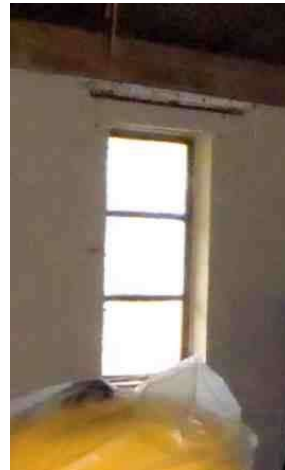
Item Number : 01490-013

Description : Window Fit

Asbestos Type : No Asbestos Detected

Original Crittal windows which were built around with brick/block so asbestos packing not used.

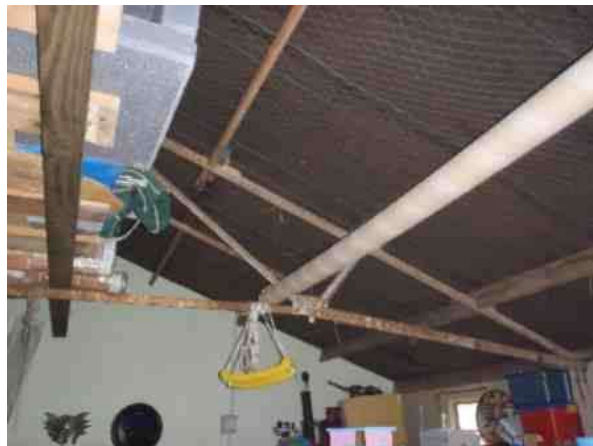
Item Number : 01490-014

Description : Inner Roofing

Asbestos Type : No Asbestos Detected
